SHILTON - FLOOD INVESTIGATION

VERSION	DATE	PROJECT NUMBER AND NAME	CREATED	CHECKED	REVIEWED
1.0	06/05/2025	5028671 – Shilton Flood Investigation	GM	SW	BM

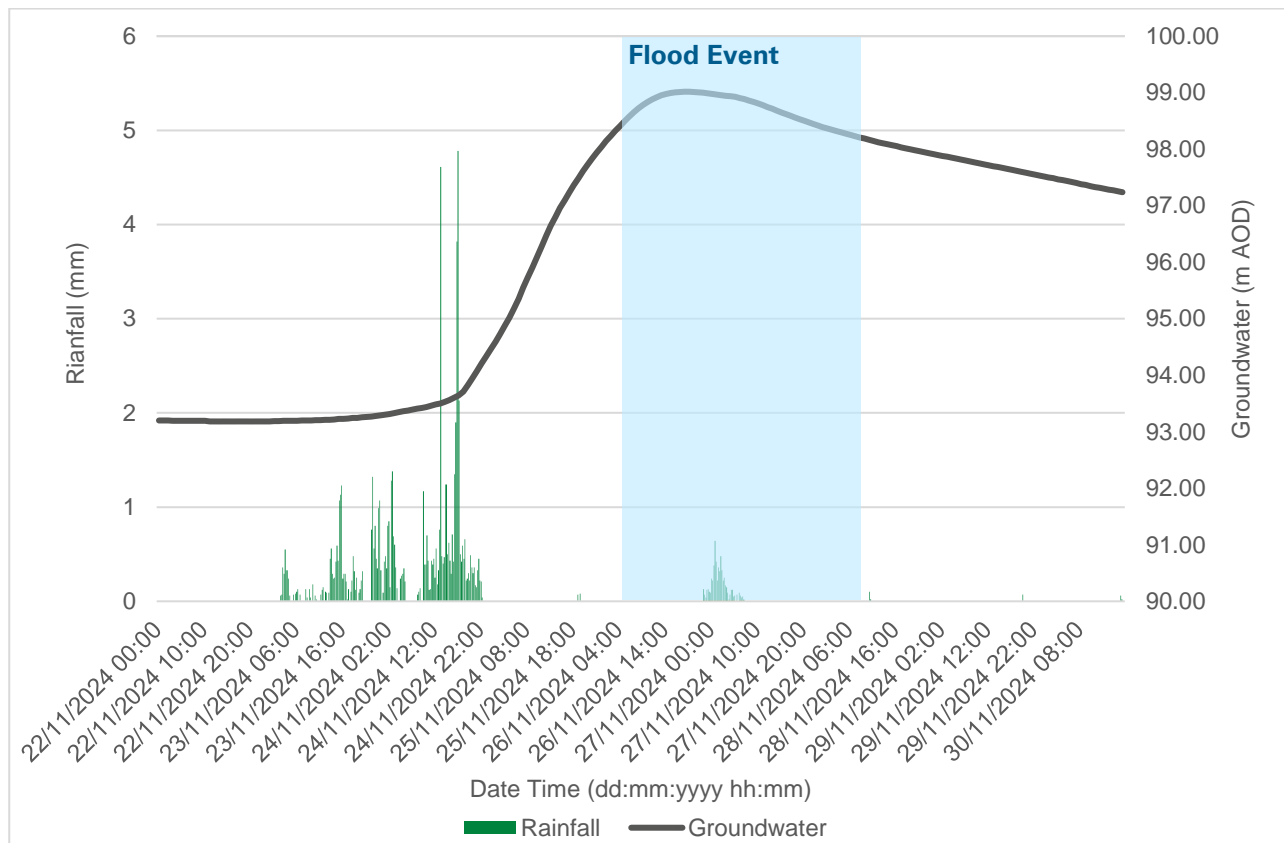
Figure 1 - Rainfall and groundwater levels during the flood event.

- 4.1.3. A large rainfall event occurred on 23rd and 24th November, with 68.69 mm of rainfall recorded over the two days at Worsham.
- 4.1.4. As a result, groundwater levels rose by 6m following the rainfall event, with groundwater recorded at over 99 m AOD on the evening of 26th November 2024, during the flood event at the village.

- 4.1.5. Since the groundwater record began (January 2019) there has been only one other instance of groundwater levels exceeding 98 m AOD, from 31st January to 2nd February 2021.

- 4.1.6. The groundwater levels remained high for several days after the initial rise in levels.
- 4.1.7. A smaller rainfall event is recorded during the flooding which is likely to have exacerbated the situation due to the already high groundwater.

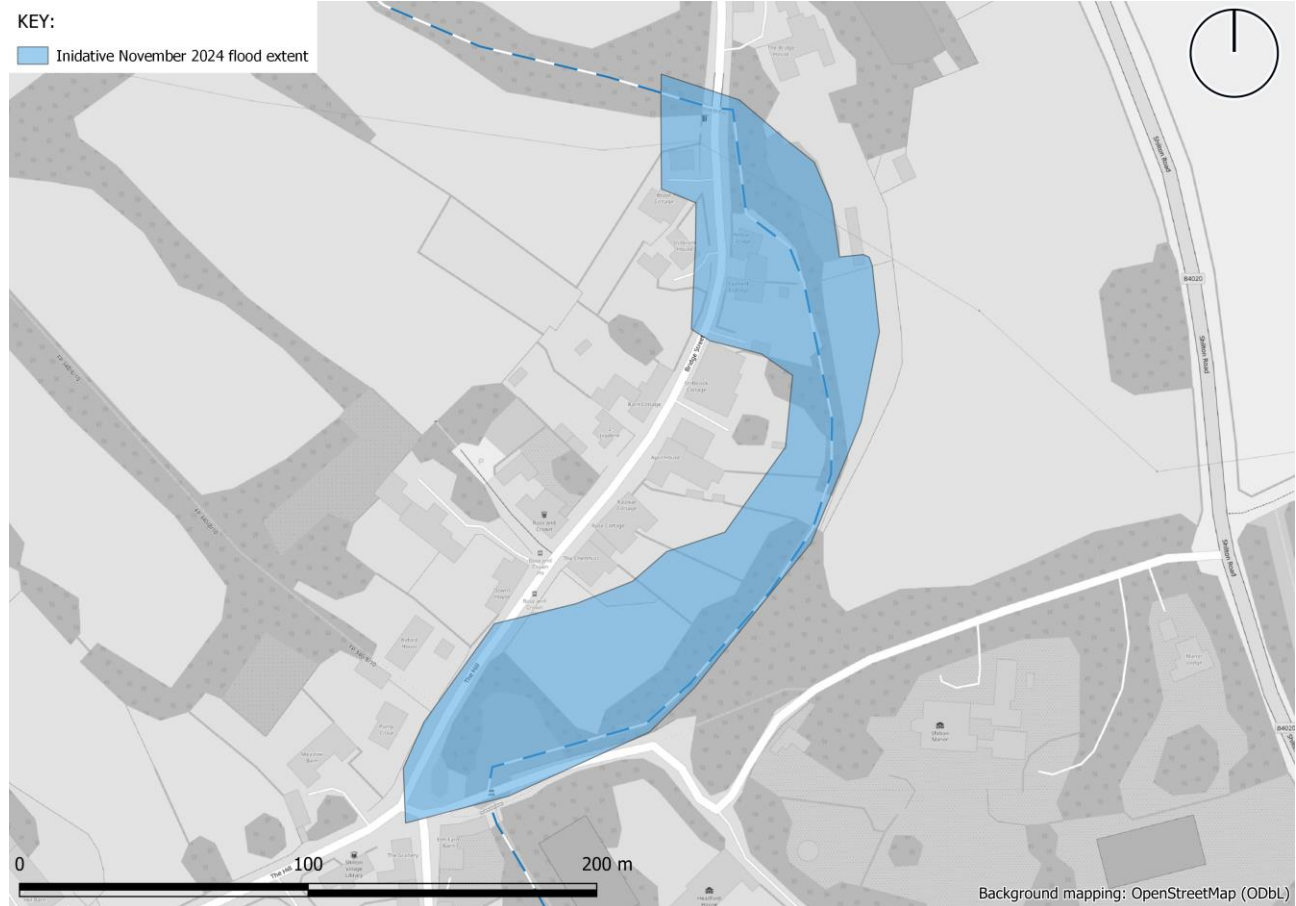
Figure 2 - November 2024 flood extent (based on the information received and discussions to date)

4.2.1. A summary of the impacts of the flooding is provided below and an image of the flood extent (based on the information received and discussions to date) is provided in Figure 2.

- Brook Cottage: Flooding from the Shill Brook enters garden and garage.
- Shill Brook Cottage: Garden flooding due to water rising from the ground.
- Rose Cottage: Flooding at the back of the property.
- Rose and Crown Pub: Flooding observed under floor boards.
- Willow Cottage: External flooding and have since installed a wall along Bridge Street to block flows and a pump to return water to the brook.
- The Forge: Flooding through floor tiles in a shed near the channel.

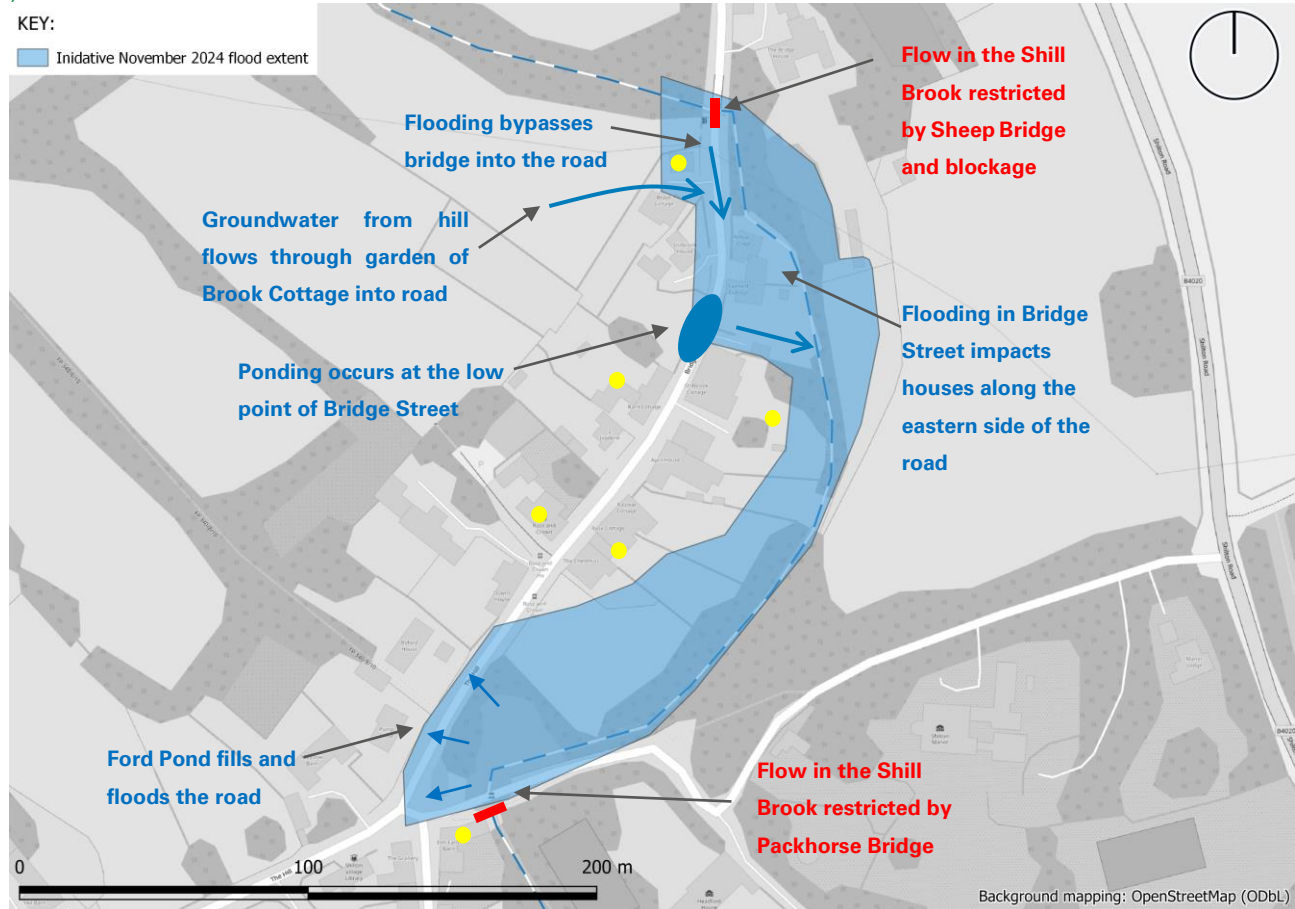
Figure 3 – Flood Mechanisms during the 2024 flood event. Locations of reported groundwater emergence indicated in yellow.

- 4.3.2. The principal mechanism of flooding appears to be the constriction of fluvial and groundwater flows at two bridges within the village, the Sheep Bridge and Packhorse Bridge:

- The Sheep Bridge is a three-arched stone bridge with a secondary two-arched structure approximately 1 metre upstream.
 - The Packhorse Bridge is a small, two-arch footbridge located at the outlet of the pond.

- 4.3.3. The capacity of the Sheep Bridge was exceeded with debris such as willow reported to have blocked the bridge, further restricting flows. Floodwater backed up before flowing through the garden of Brook Cottage and into Bridge Street. Once in the road, flooding affected houses at the eastern side of Bridge Street and flooding was trapped without a connection back into the Shill Brook.

- 4.3.4. Overland flows were reported to have come from the hillside west of Brook Cottage, one to two days after the rainfall. The delayed response suggests that this overland flow was due to groundwater emergence within the adjacent field. There were also several reports of flooding rising up through internal floors and gardens.

- 4.3.5. At the downstream extent of the village, the Packhorse Bridge also contributed to flooding in the village. The pond fills during high flows and can overflow, impacting nearby roads and buildings. While flow is generally contained within the Shill Brook channel downstream of the village pond, flooding has been observed to rise through floors and tiles in outbuildings such as The Forge.

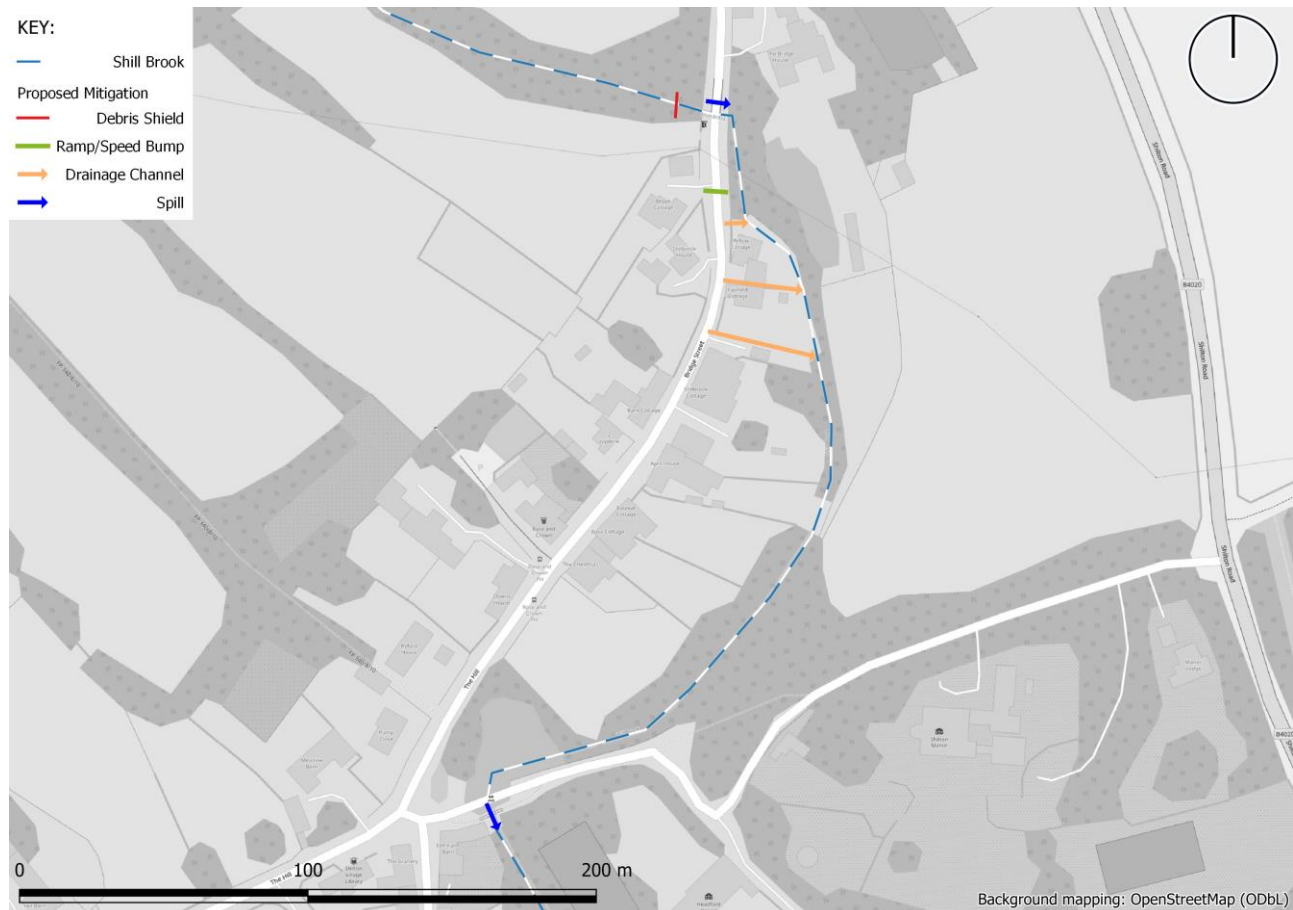
Figure 4 - proposed mitigation measures.

- 5.1.1. Currently, there is no detailed hydraulic model available from the EA for this area, which limits the ability to test and quantify the effectiveness of flood mitigation options. However, potential mitigation options (shown on Figure 4) are outlined below based on the understanding of flooding mechanisms outlined in the previous section.

1. Debris shield - Install a debris shield upstream of Sheep Bridge to intercept debris before it can reach the bridge and result in blockage. This should be regularly maintained and cleared to ensure there is no debris build up and flows can pass freely through.

2. Increase the flow capacity of the bridges:
 - Amend existing structures - remove double upstream face of Bridge Street bridge and central support of the ford bridge to increase flow capacity. However, it is understood that both bridges are listed, which may limit opportunities for physical changes

- High flow spills over bridges – it has been reported that there is sufficient channel capacity downstream of both bridges. As such installing high-level bypass culverts or other spills at both bridges to allow floodwaters to bypass the structures should be considered. It should be noted however that any proposals to increase the flow capacity of these structures would need to demonstrate that they do not increase flood risk downstream, requiring a flood modelling assessment.

3. Redirect flooding from Bridge Street back into the Brook:
 - Install a ramp or speed bump along Bridge Street to divert flows back into the Brook before they can pass down the street and impact houses.

- Provide a new connection / drainage channel from the low point in Bridge Street back into the Shill Brook. This would enable flooding to quickly return to the Brook and reduce flood risk to properties along Bridge Street.

- 4. Property Flood Resilience (PFR) – many properties have already installed PFR measures, such as pumps and flood boards. This should be encouraged throughout the village and installed where necessary.

- 5. Flood Warnings - Ensure all residents are signed up to flood warnings and village wide alert system is in place in case individuals do not receive the warning. The installation of a flood gauge (flow / level) in Signet could be used to provide a warning approximately 7 hours before flooding would be expected to occur, based on the 2007 flood event.
